U.S. ENVIRONMENTAL PROTECTION AGENCY
POLLUTION/SITUATION REPORT
2015 Gold King Mine Release SITREP

Subject: Situation Report #8
Gold King Mine Release
San Juan County, CO
Latitude: 37.8945 Longitude: -107.6384

From: Durango Unified Command (Situation Unit)

Date: 08/16/2015
Reporting Period: 08/15/2015 through 08/15/2015
Website: <http://www2.epa.gov/goldkingmine>

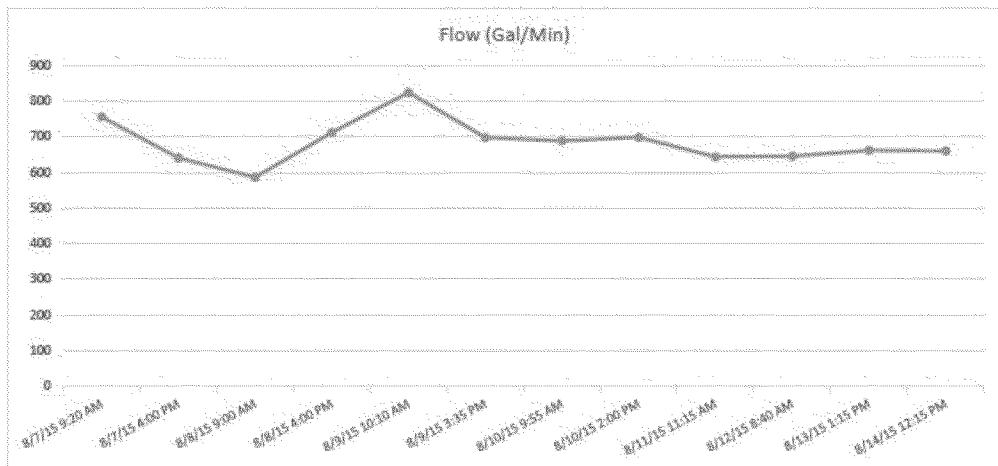
Flow from the mine through the morning of 8/14/2015 is shown in the following chart. The flow chart will be updated for the next SITREP. **The treatment pond effluent pH on the afternoon of 8/13/2015 was 4.95.**

Treated water from the last treatment pond is discharging into Cement Creek. Flow data out of the mine is being collected manually two times per day. Water quality data is being collected at the influent and effluent of the treatment system as well.
